**From:** tgablehouse@gcglc.com  
**Sent:** Friday, September 22, 2017 9:42 AM  
**Subject:** CSB has released photos of the fire aftermath at Arkema in Houston  
**Attachments:** Photos of Arkema Plant aftermath.pdf

# These stark photos show the charred aftermath of the Texas chemical fire that ignited after Harvey

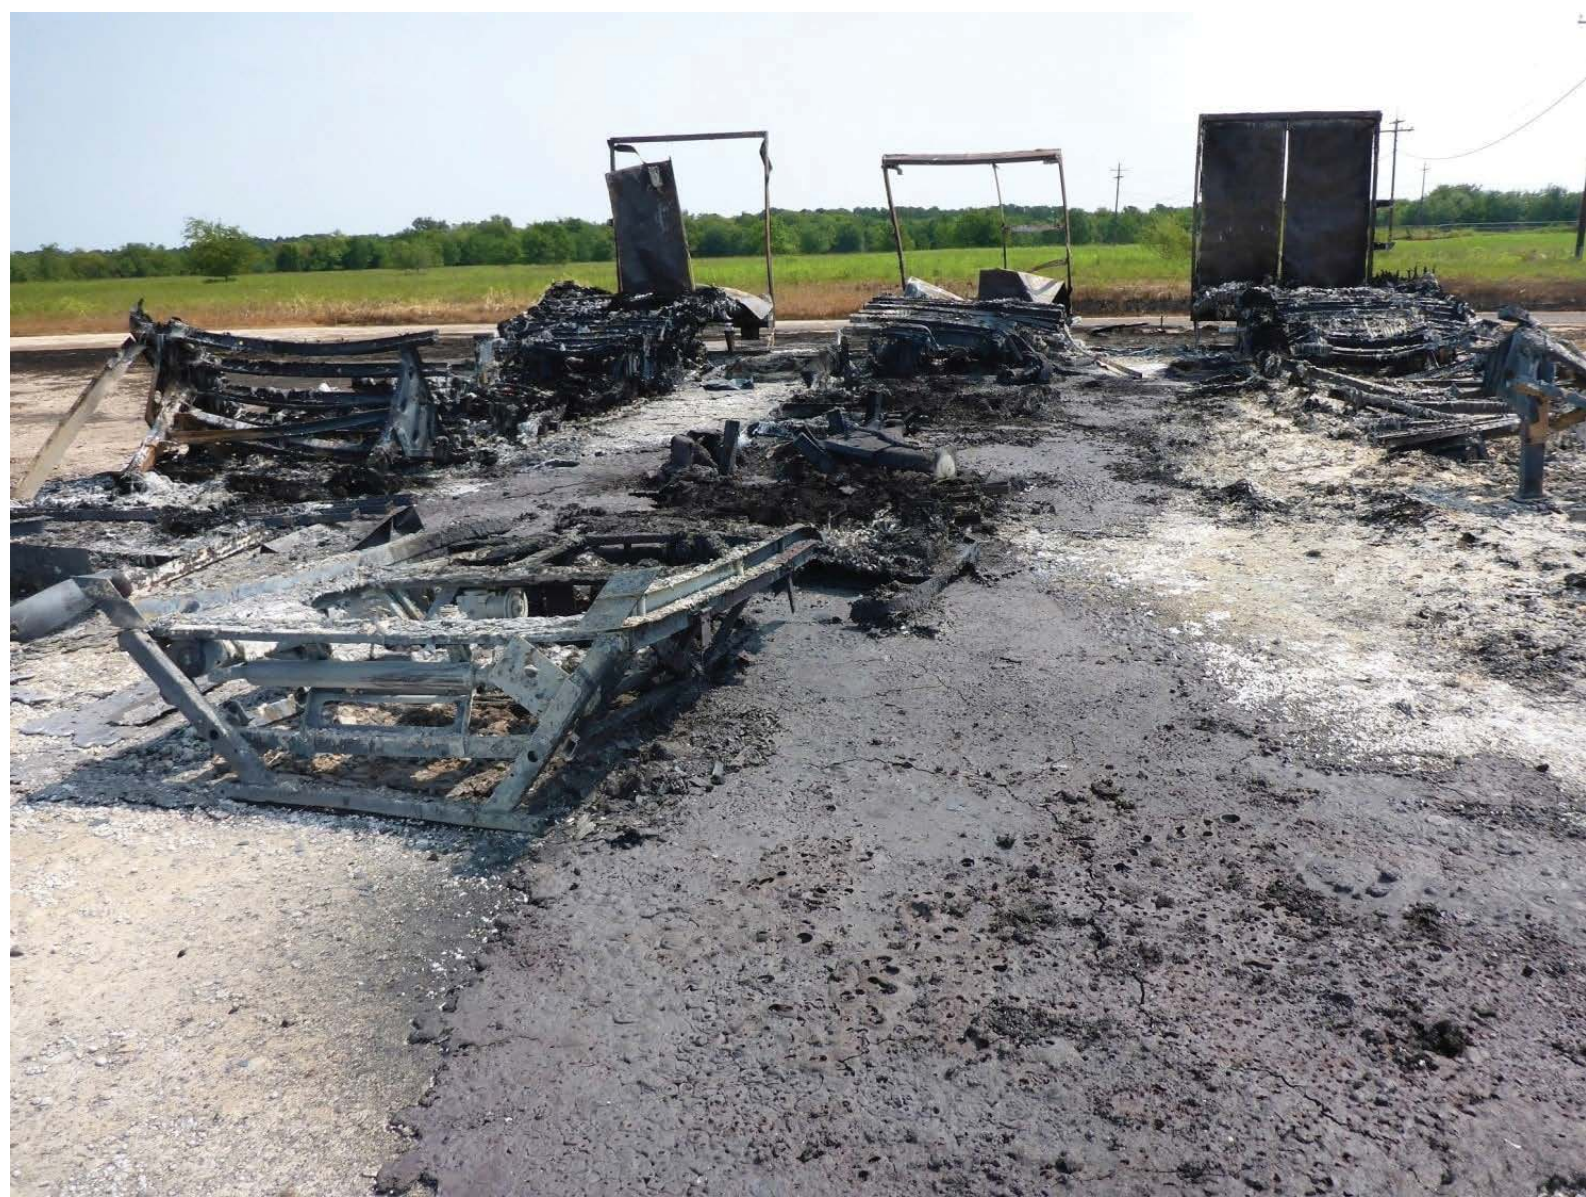
The charred remains of trailers that contained organic peroxide products that burned during the fires at the Arkema facility in Crosby, Tex. (U.S. Chemical Safety Board)

Two of the photos show the skeletal remains of three shipping-size containers covered with ash near the edge of the Arkema facility. Another shows a container burned beyond recognition in front of a charred warehouse.

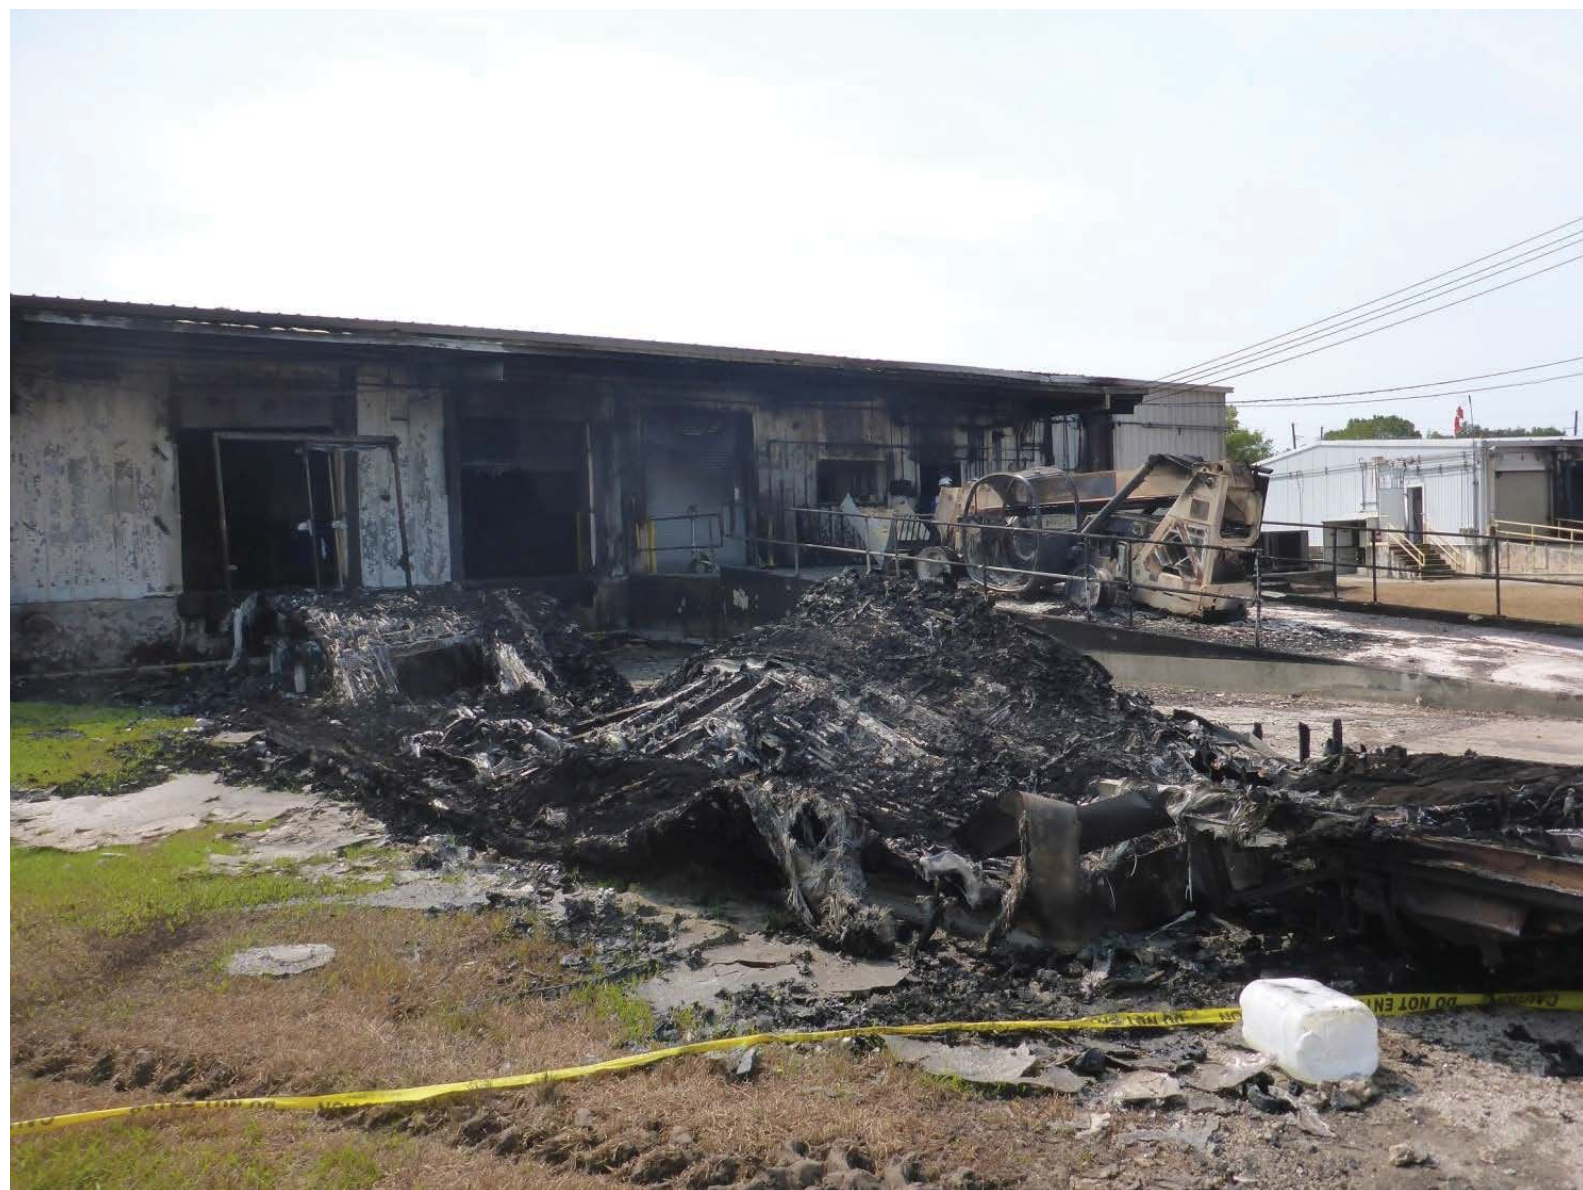
A trailer that contained organic peroxide products that burned during the fires at the Arkema facility in Crosby, Tex. (U.S. Chemical Safety Board)
